TECHNICAL REPORT ARPAD-TR-81002

**X-RAY SCANNING METHOD FOR DETECTION
OF
GAPS IN ASSEMBLED TANK AMMUNITION**

NOVEMBER 1981

US ARMY ARMAMENT RESEARCH AND DEVELOPMENT COMMAND
PRODUCT ASSURANCE DIRECTORATE
DOVER, NEW JERSEY

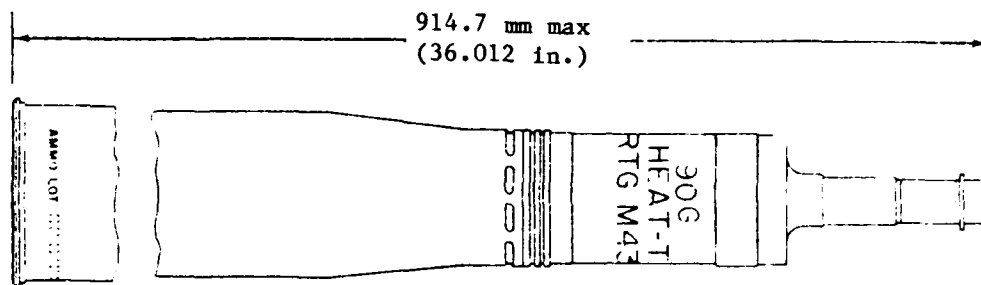
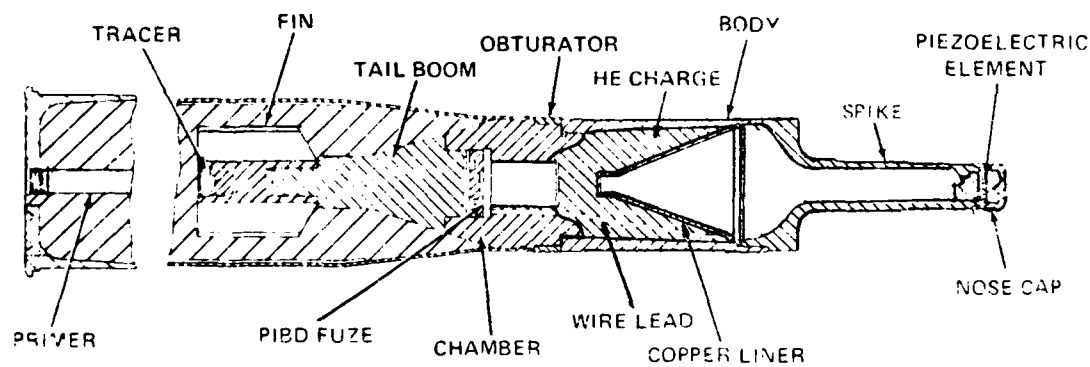
Figure 1. 90-mm HEAT-T cartridge M431

When it became evident that certain 90-mm tank ammunition (HEAT-T M431) might be defective because a gap could exist between the mating faces of the aluminum chamber and the steel warhead (they might not be completely screwed together), a simple but reliable inspection technique was required. The metal feeler gauge method used during manufacture was not appropriate since the gauge could not be inserted past the plastic obturating band after the cartridge case had been crimped onto the warhead assembly. The cartridge case has a tendency to hold the obturating band forward against the rear face of the steel warhead (figs. 1 and 2). Radiography seemed to be the natural choice for the inspection, since penetration of the plastic band by an X-ray beam could be easily accomplished.

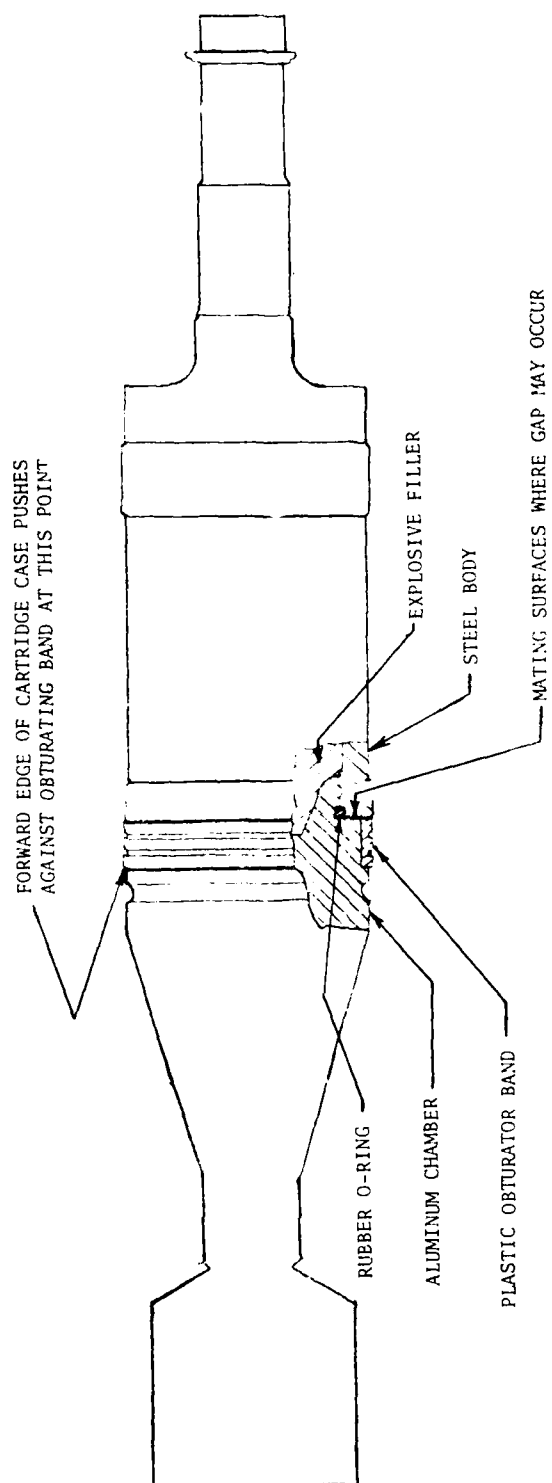
Figure 2. 90-mm projectile M431

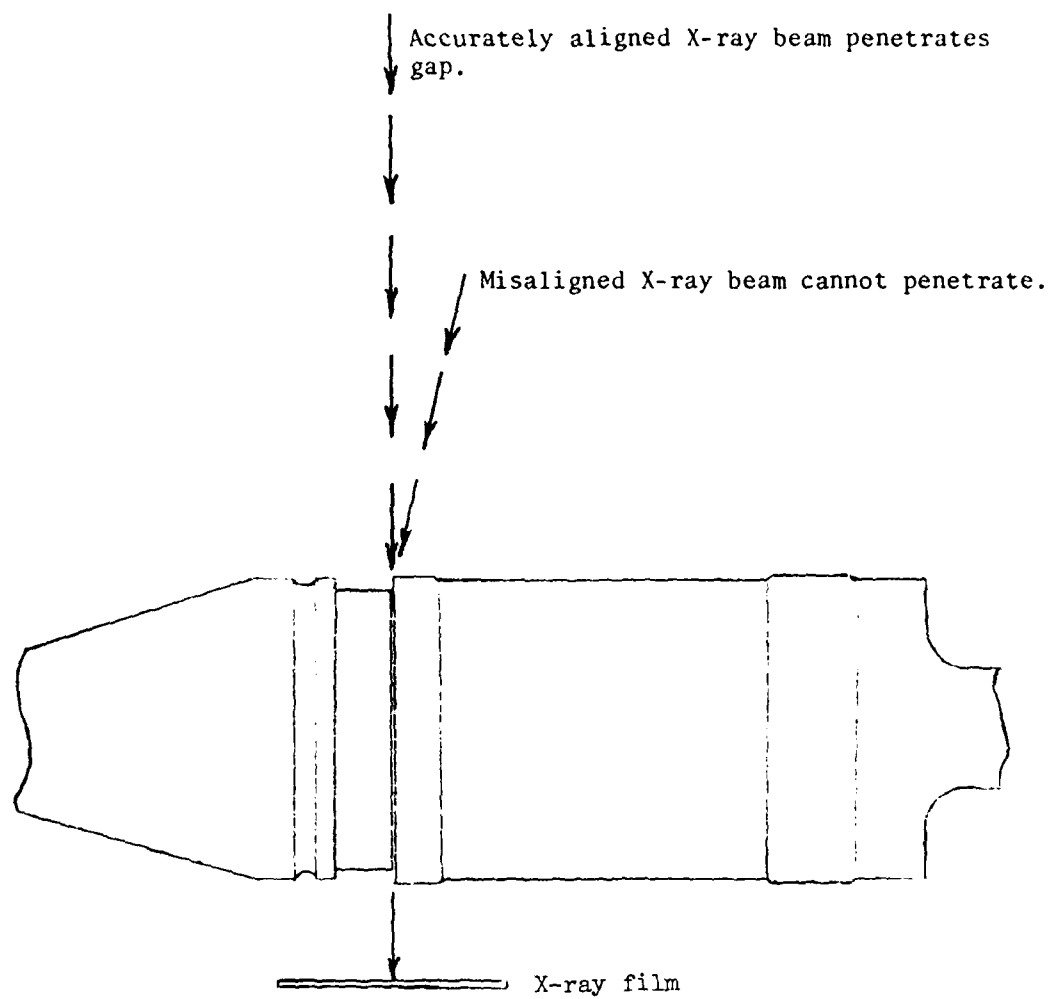
Figure 3. Projectile segment without obturating band

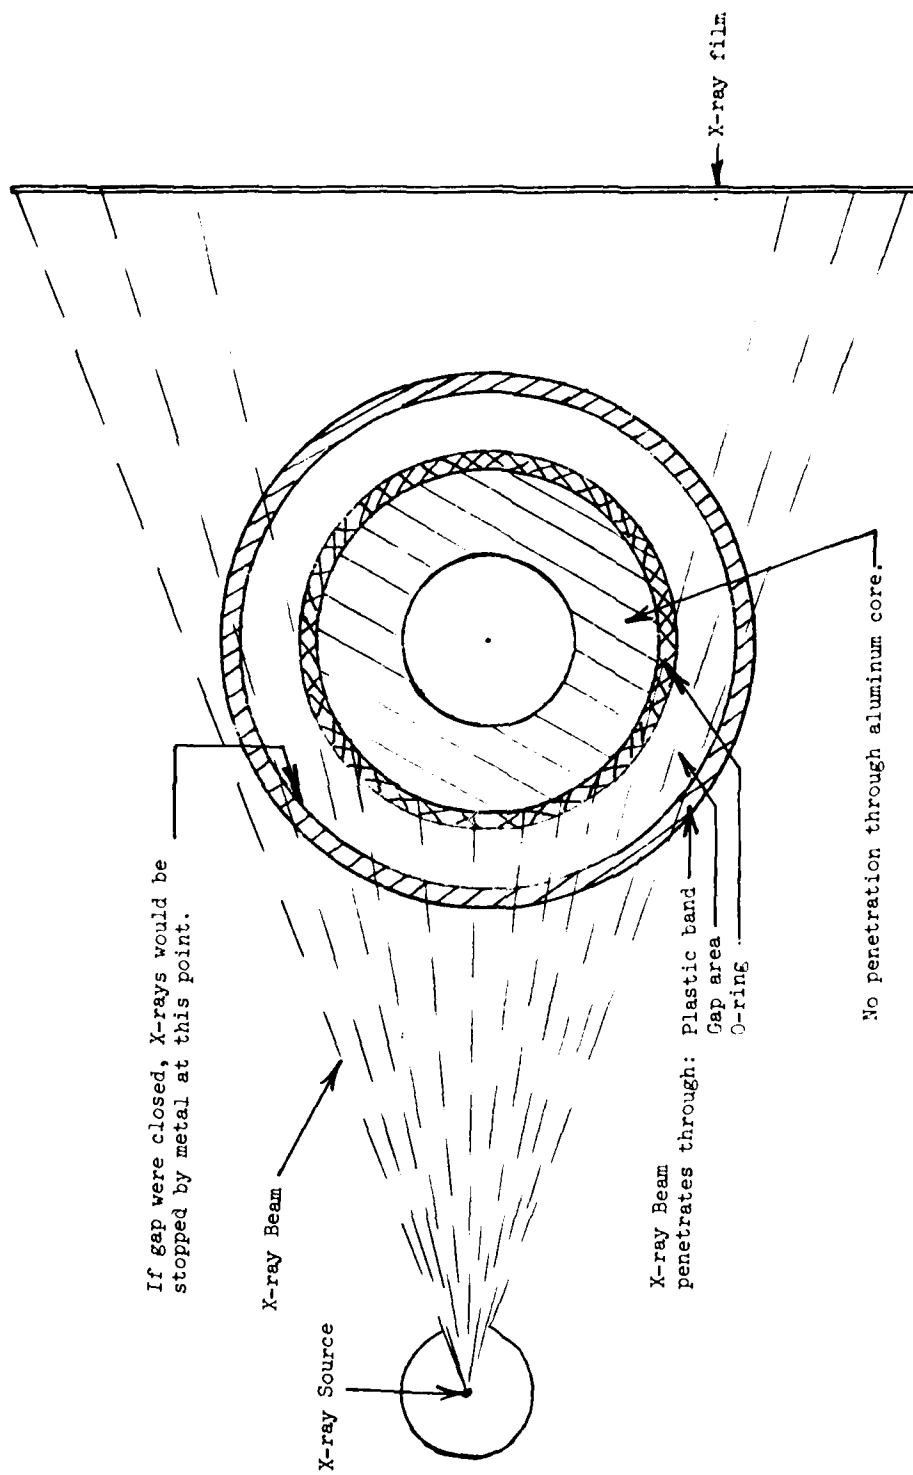
Figure 4. End view of projectile at the gap plane

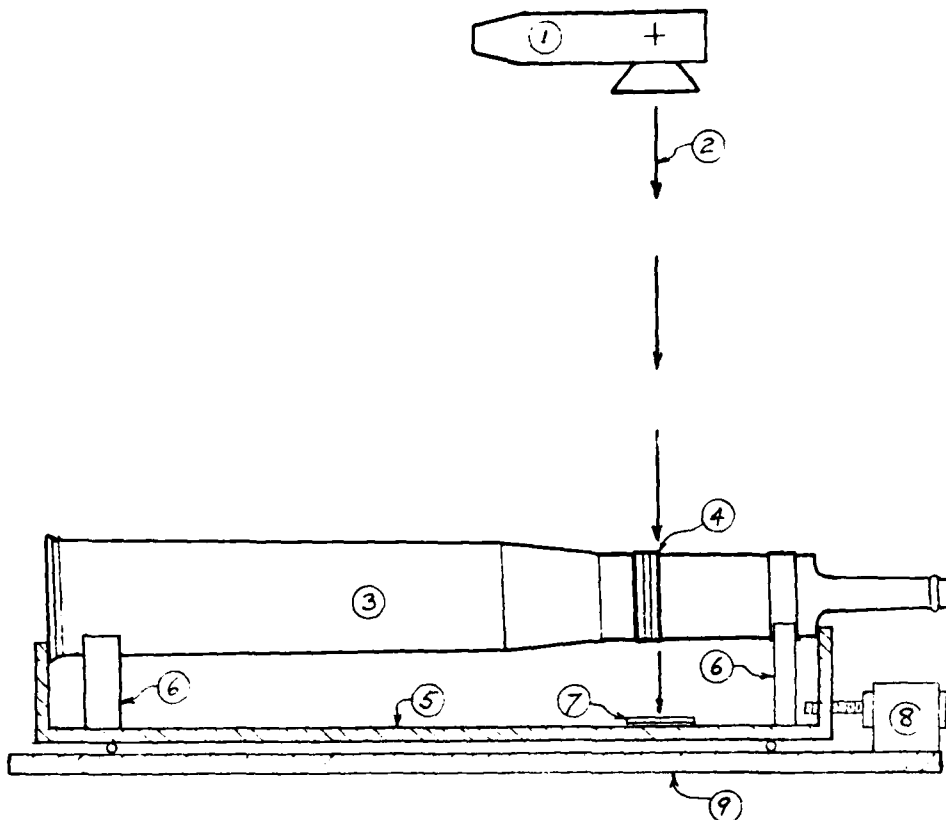
1. X-ray tube head (source)
2. X-ray beam
3. 90-mm HEAT-T cartridge M431 (complete round)
4. Gap area (interface between body and chamber)
5. Sliding fixture (aluminum) with end brackets to position shell longitudinally
6. V-blocks (aluminum) mounted on sliding fixture to position shell vertically and laterally
7. X-ray film cassette
8. Reversible drive motor with precision lead screw to move sliding fixture at 2 inches per minute
9. Support base or table (aluminum)

Figure 5. X-ray scanner for 90-mm cartridge M431

As seen in the radiographs (figs. 6 and 7), the distinction between a gap and no-gap condition is quite clear. We now consider this technique ready for adaptation to production inspection of stockpiled ammunition either in the laboratory or at field locations. The concept is illustrated in figure 5. Future efforts should concentrate on improving the engineering design of the equipment and optimization of techniques for economy. The principal need is for a more rugged, semi-automatic, scanning and indexing fixture. An X-ray shielding box with rapid access for loading and unloading will be needed if a field operation is to be conducted (fig. 8). Improved material handling devices and a more economical film may be possible. A self-checking X-ray alignment standard will be required. Application of this technique to inspection of other ammunition items must await further feasibility studies.

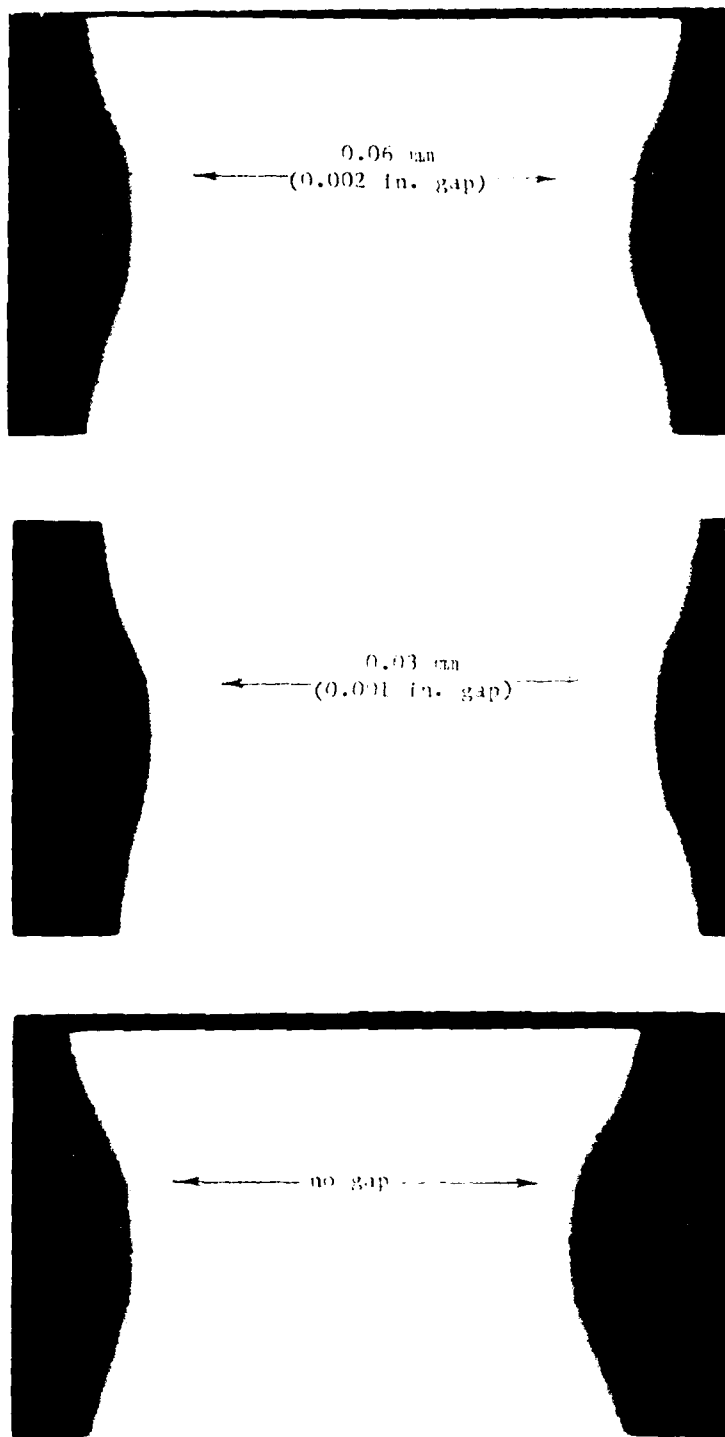
Figure 6. Photographs of radiographs showing gap area

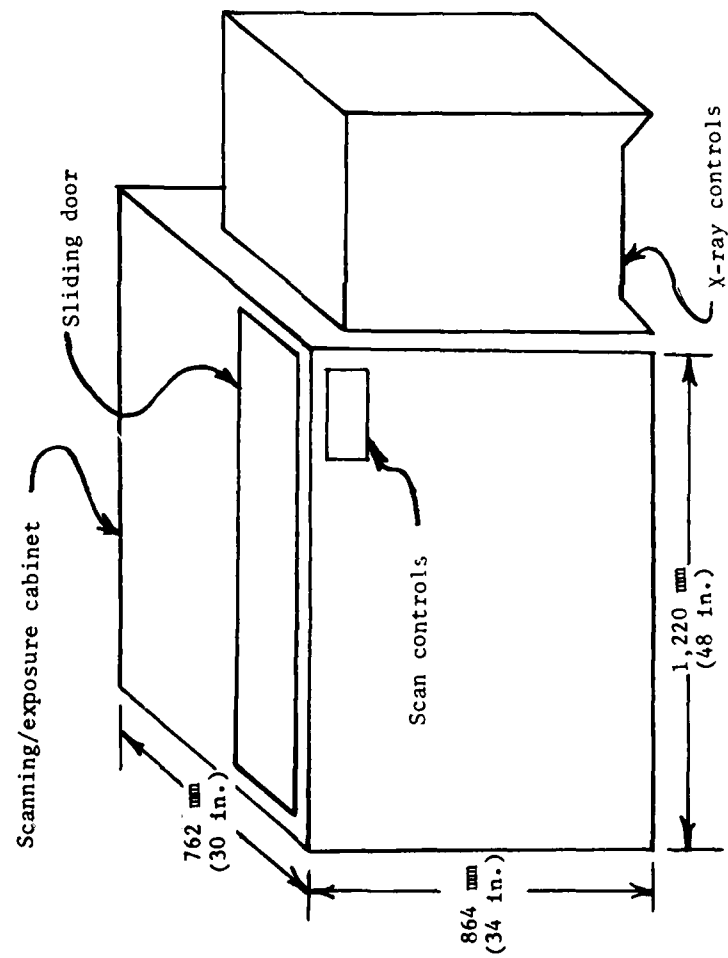
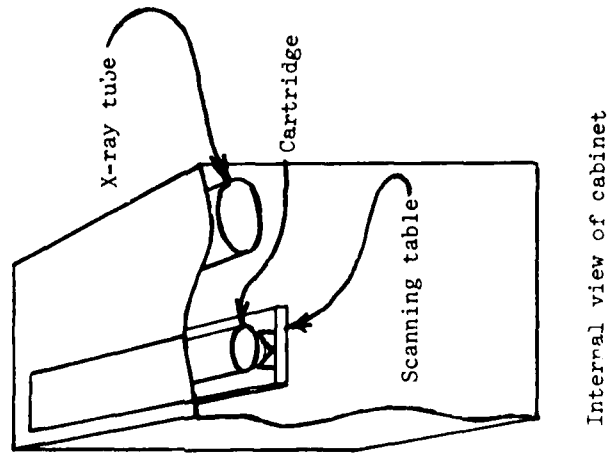
Figure 8. Sketch of self-contained X-ray scanning system for 90-mm cartridge inspection
